Why did the *MSC Zoe* lose containers overboard?

Extensive environmental damage caused by a massive loss of containers from *MSC Zoe* last year has led to a warning that two busy North Sea shipping routes are a risk to large vessels – and a long list of recommendations.

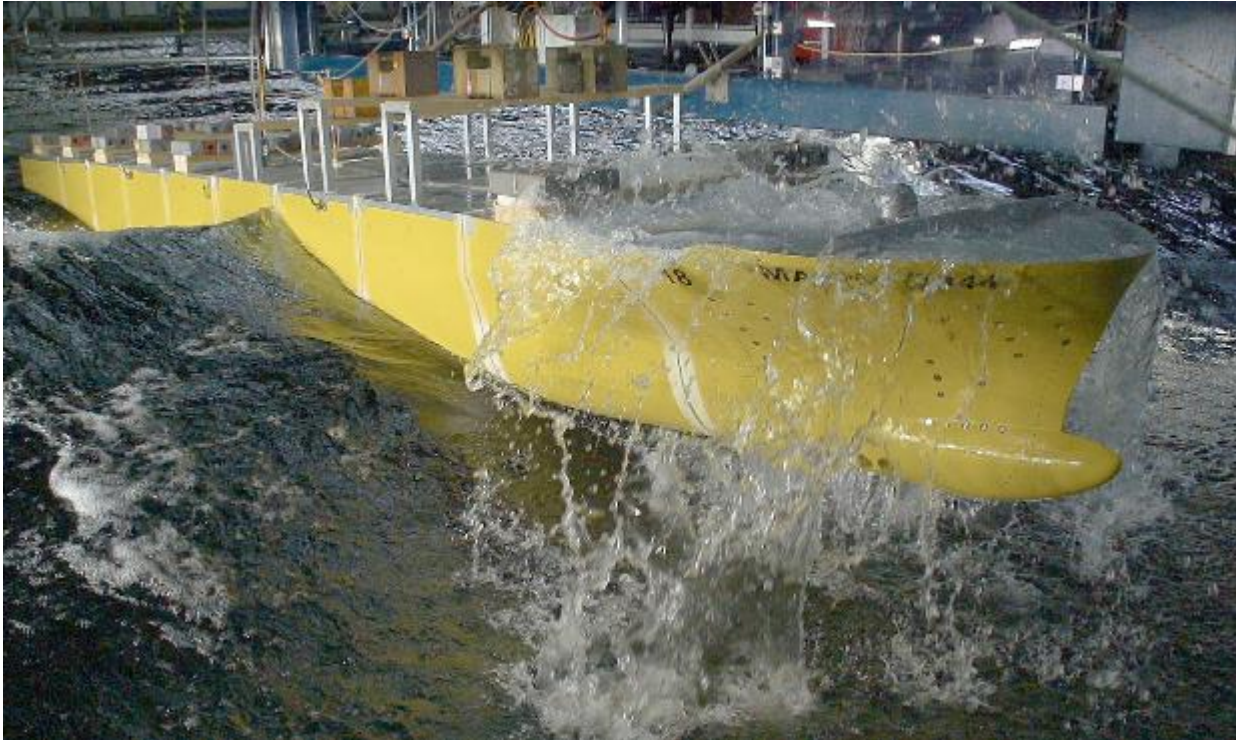
Test tank at MARIN (Maritime Research Institute Netherlands)

The Dutch Safety Board, which has coordinated a number of investigations into the incident, asked MARIN (Maritime Research Institute Netherlands) to undertake extensive tank tests with a ship model to try and gain insight into the conditions and ship motions that occur around the Wadden Islands.

The results, according to the Dutch Safety Board, provide important new insights into wave and sea phenomena that can lead to container loss.

The team found that in storm force, north-westerly winds, ships in the area can encounter high waves athwartships (perpendicular to the fore-and-aft line of the vessel).

As a consequence, large, wide, container ships can make extreme rolling movements, waves can slam against the ship, and seawater travelling at high speed along the side of the ship can be forced upwards against the containers. These phenomena, individually and combined, can cause

extreme forces to act on the ship, the containers, and the lashing systems. Containers can break free and be washed overboard.
